# ***HTS Fault Current Controller Restoration Project***

## **Los Alamos National Laboratory**

**Annual Peer Review Meeting, August 1-3, 2001  
DOE Superconductivity Program for Electric Systems**

# **HTS Fault Current Controller Restoration**

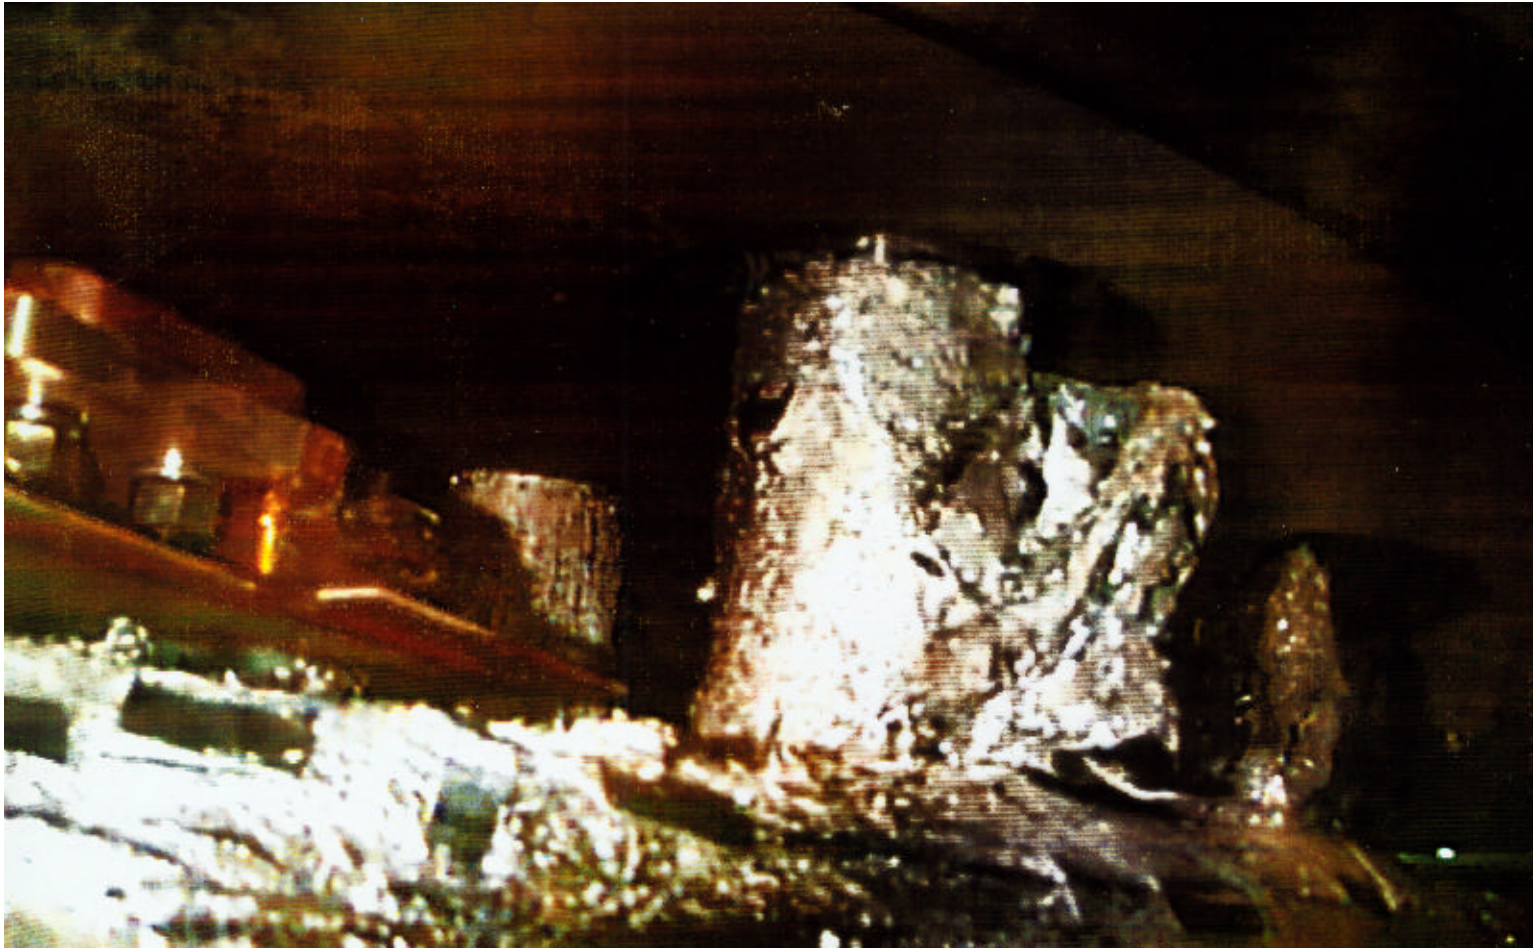
# Damaged Multi-Layer Insulation (MLI)

- All three vessels were removed from FCC trailer and transported to power supply building.
- All three vessels were opened and inspected.
- Vessel of phase A has no visual damage  
A helium leak occurs at low temperatures
- Vessel of phase B and C have burn marks around the HV bus and the low voltage super-insulation; arcing occurred also to the vacuum vessel; location of flashover is the same
- No damage to HTS coils apparent
- No voltage breakdown at aluminum nitride component

- Electric field displaces loose MLI.
- Arc to unconstrained MLI near penetration vaporizes material.
- Produces local gas cloud
- Reduces discharge strength
- Arc is initiated
- Vaporize 30 cm<sup>2</sup> to raise pressure to 10<sup>-4</sup> torr (locally pressure much higher)

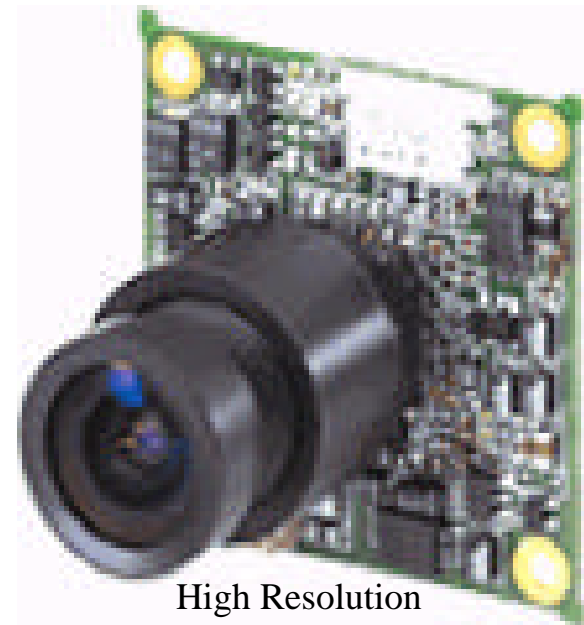
High Resolution  
CCD cameras  
~\$150 each

Camera for viewing arc discharge  
in FCC vacuum vessel
